46TH TURBOMACHINERY & 33RD PUMP SYMPOSIA
HOUSTON, TEXAS | DECEMBER 11-14, 2017
GEORGE R. BROWN CONVENTION CENTER

Gas turbine with rotor crack vibration diagnostics

Machine train: Gas Turbine - Generator

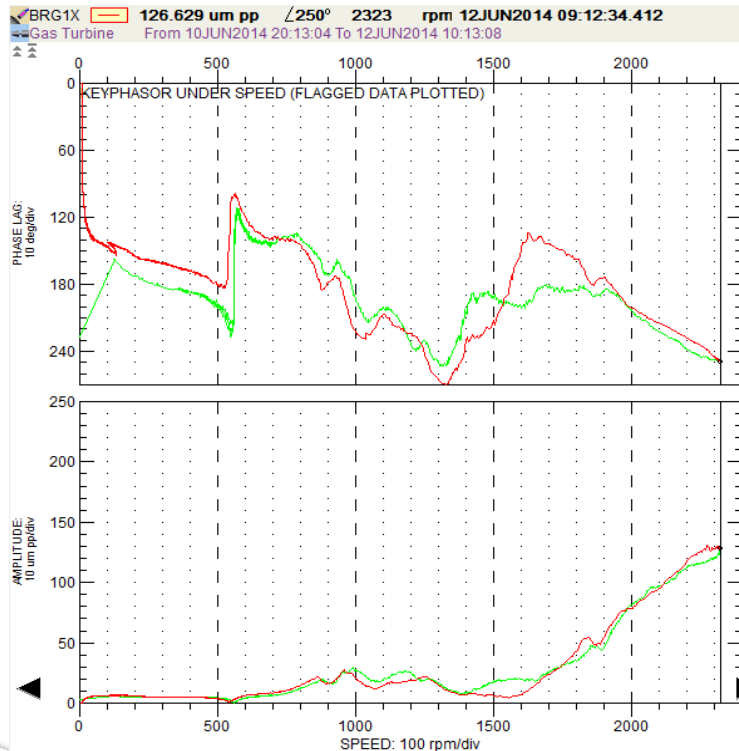
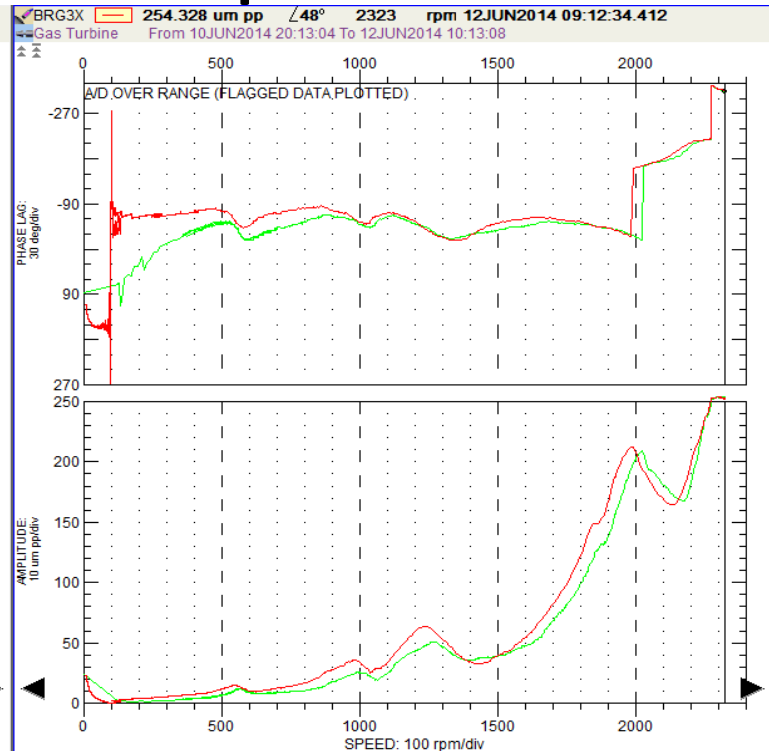
First Start up

During Start up, the unit reached the trip levels at bearing 1 vertical seismic transducer (28.8mm/s pk) at 2221rpm and was tripped manually.

- the coupling balancing is suggested in the first step to pass the resonance
- after unit can pass the critical speed the next evaluation of the alignment for machine hot conditions is recommended.
- bearing 3 looseness, soft foot suspected

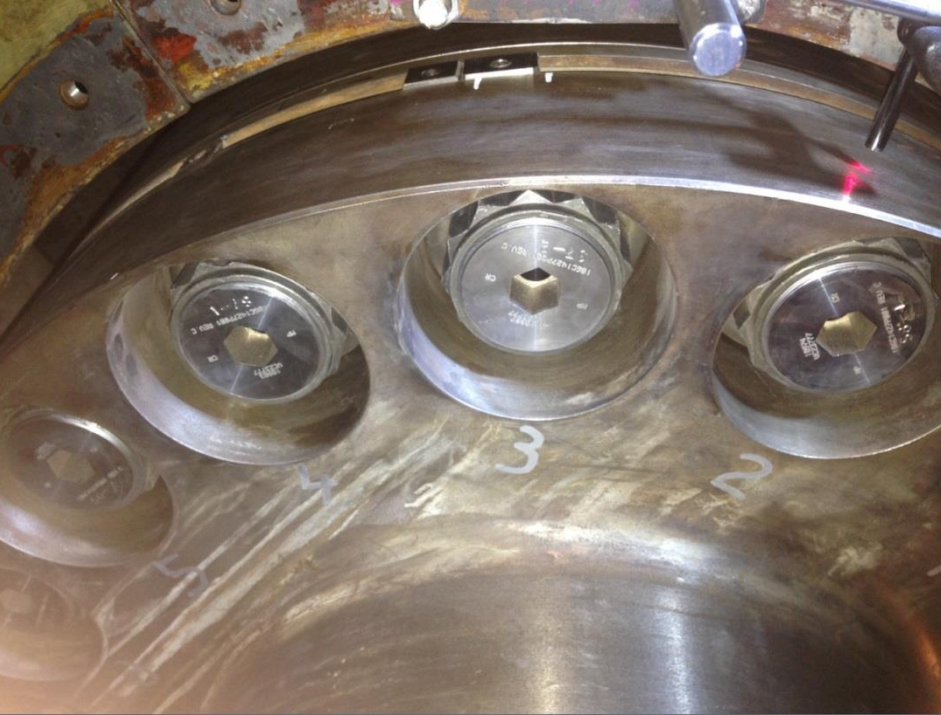
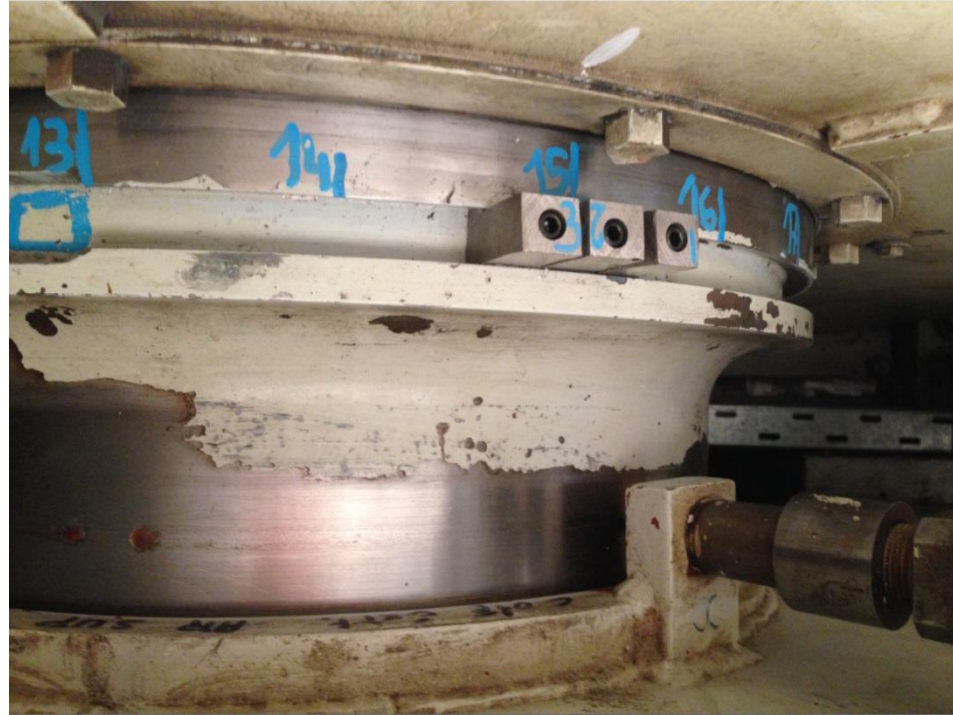
Balancing - Generator balanced

The Generator successfully balanced and the 1X vibration levels on the Generator bearings are in Zone A, according to the ISO 10816-4.

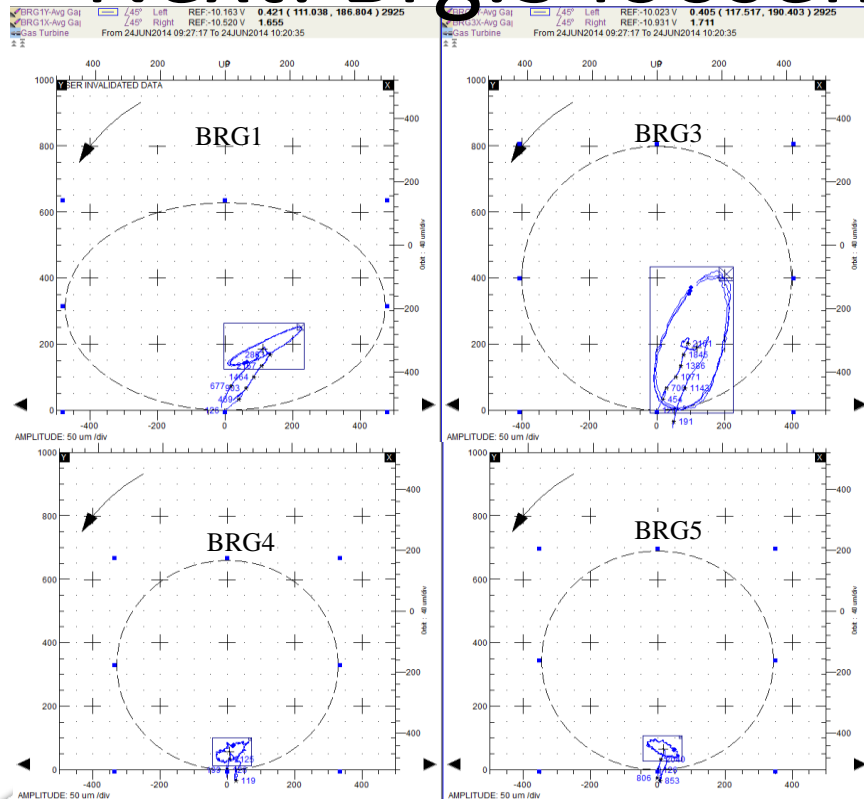
SCL position in bearing 3,4 abnormally low, metal temp low suggest misalignment Brg 3 orbit shape, extreme size and vertical orientation may be due to lowered stiffness and bearing 3 looseness or soft foot

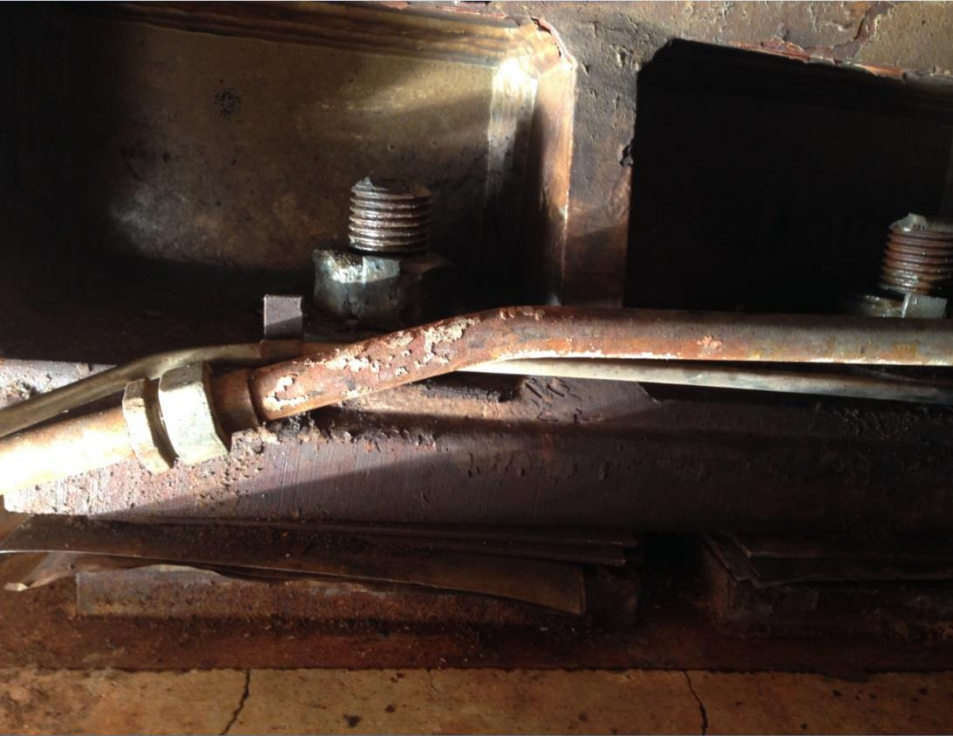
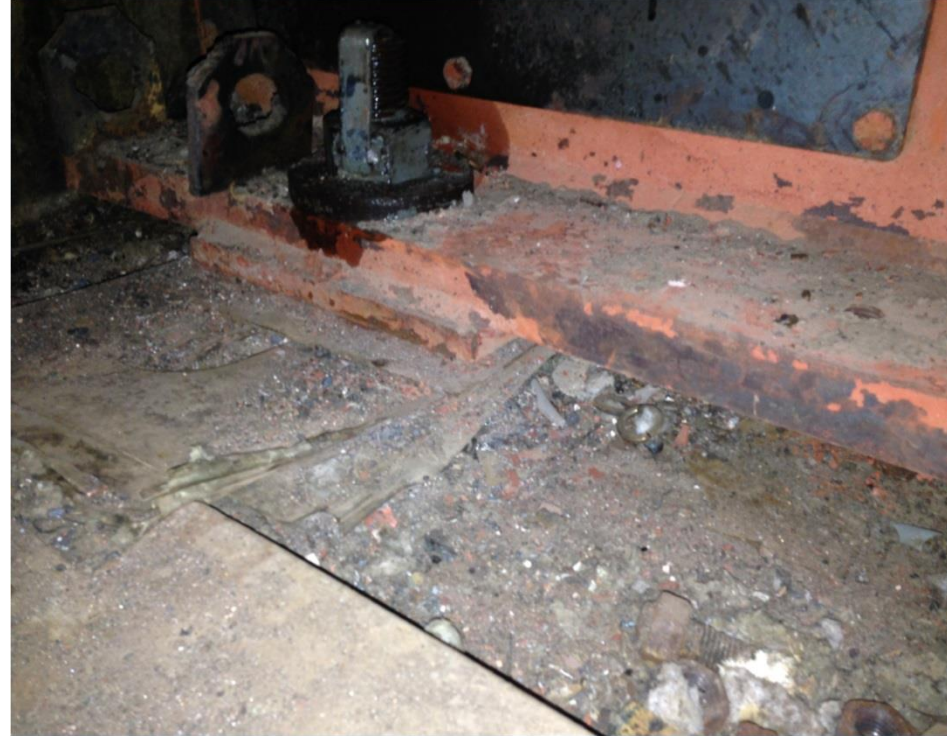
Brg.3 looseness, soft foot

Gas Turbine Bearing 3 base plate shims moved, after reinstalling same height shims, Brg3 base plate raised 200/250um left/right

- Bearing 3 opened, clearances were checked
- Alignment Gas Turbine – Generator was performed
- Gas Turbine soft foot check performed on all the foots
- Bearing 1 opened, clearances were checked

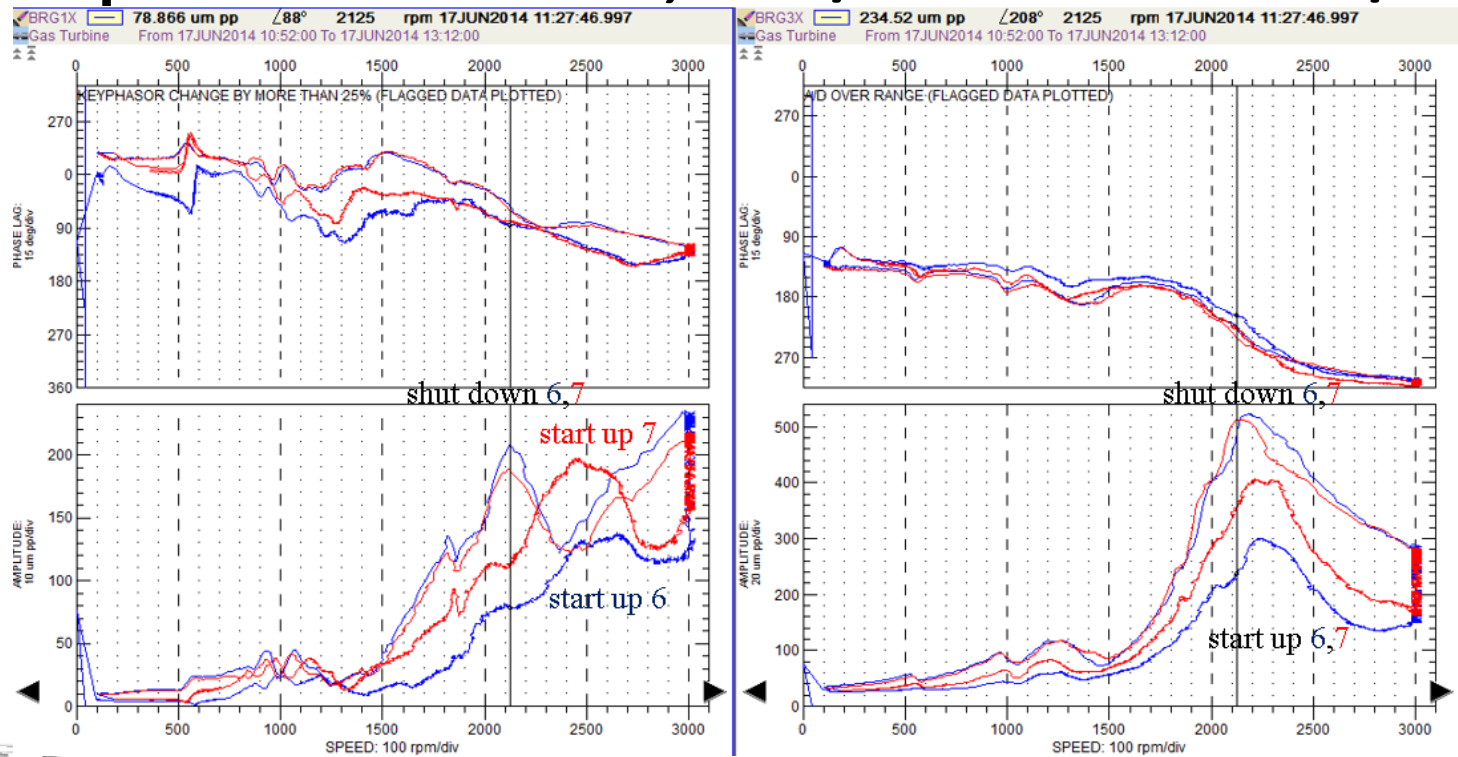
Comparison of 1X, SU/SD6 and SU/SD7

difference in critical speed between SU and SD, repeatable SU and repeatable SD
small change in slow roll

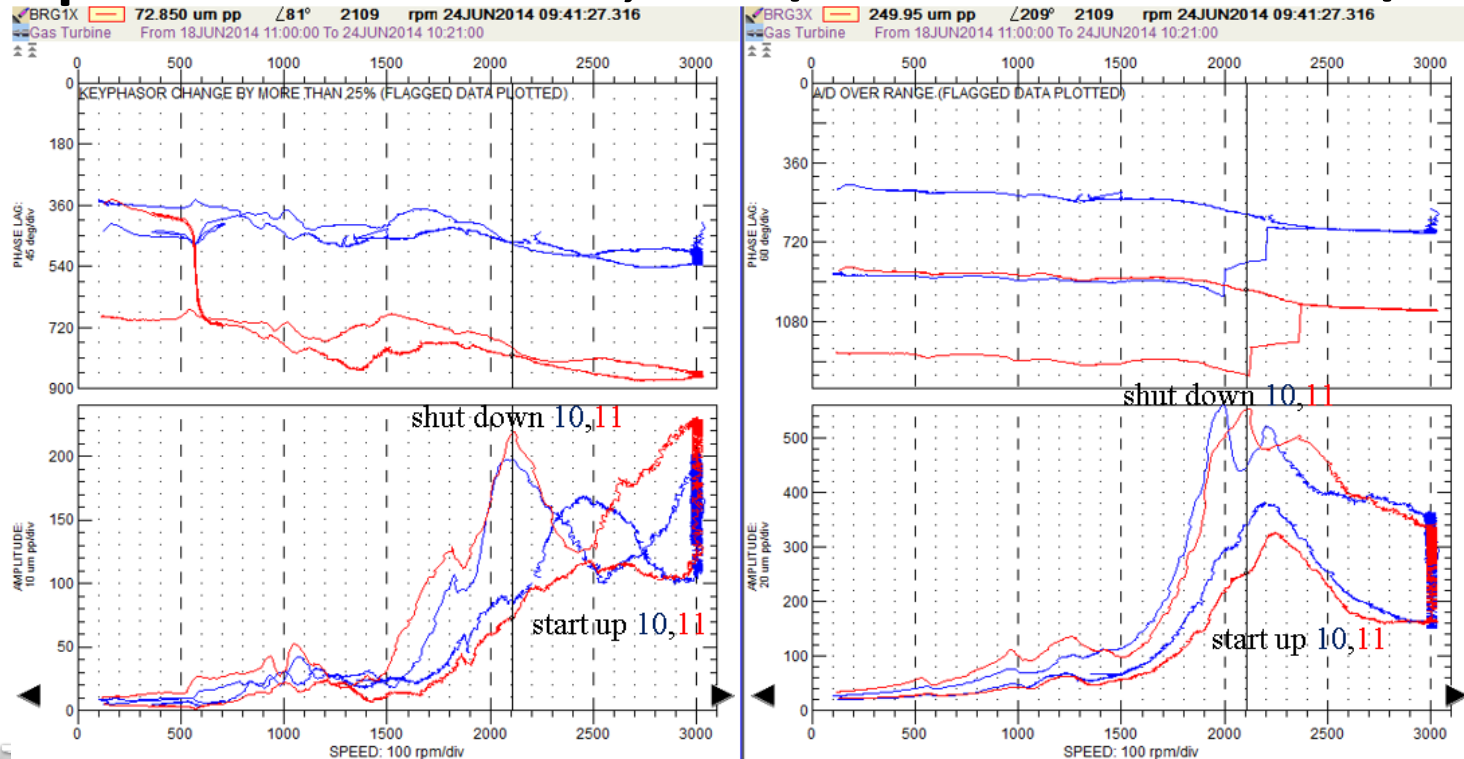
Comparison of 1X, SU/SD10 and SU/SD11

difference in critical speed between SU and SD, repeatable SU and repeatable SD
small change in slow roll (6-14umpp), and split resonance appeared

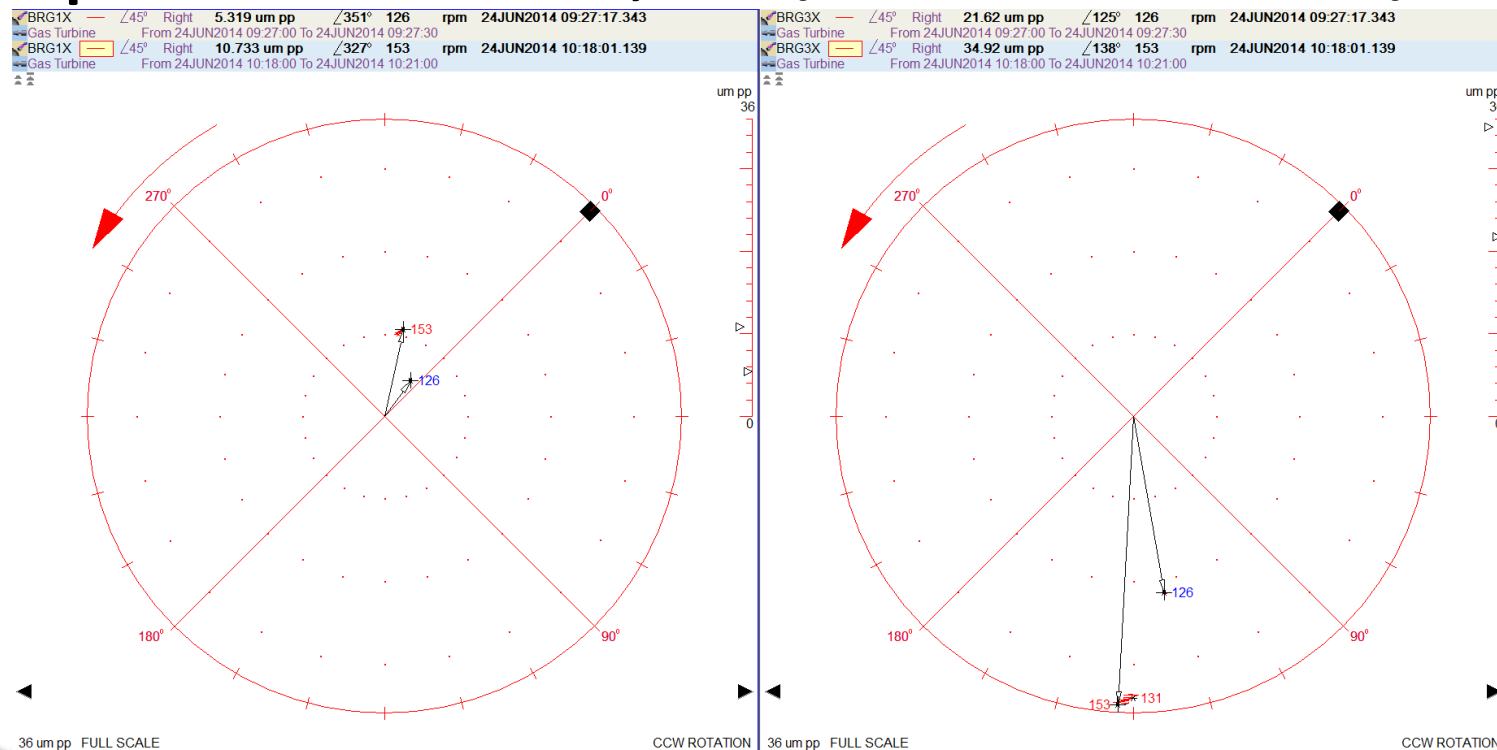
Comparison of 1X, SU/SD10 and SU/SD11

small change in slow roll (6-14umpp)
unidirectional change

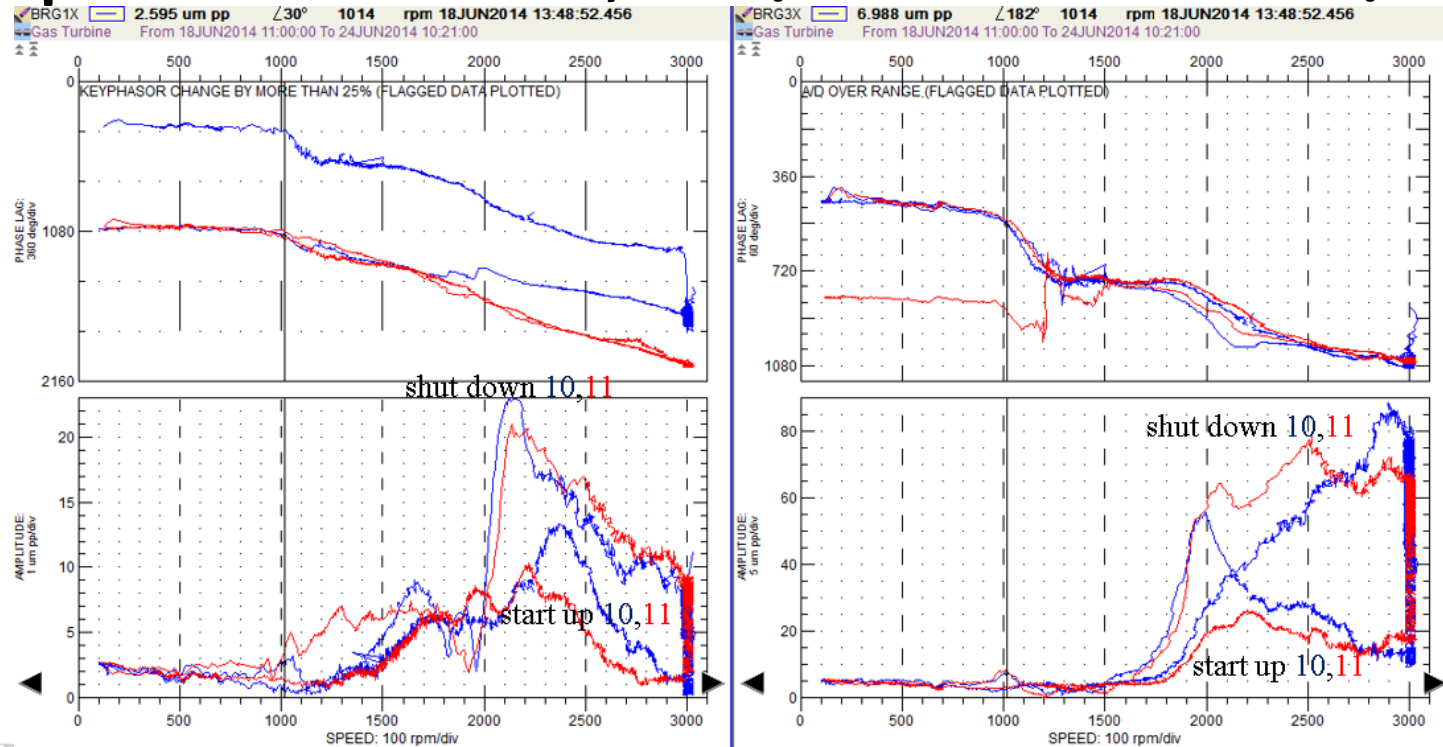
Comparison of 2X, SU/SD10 and SU/SD11

2X component NOT greatly amplified at half of resonance
2X amplified at critical speed is due to Nonlinear Stiffness

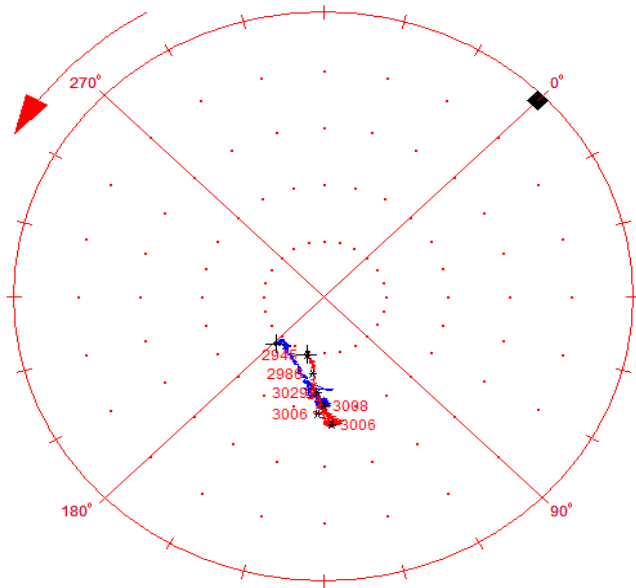
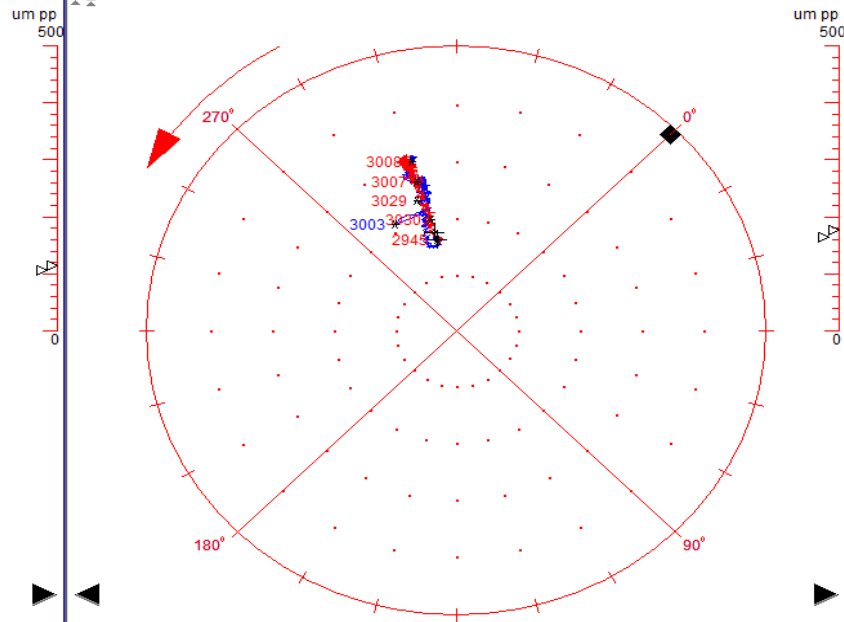
Steady State 1X, SU/SD10 and SU/SD11

repeatable unidirectional change of 1X vector

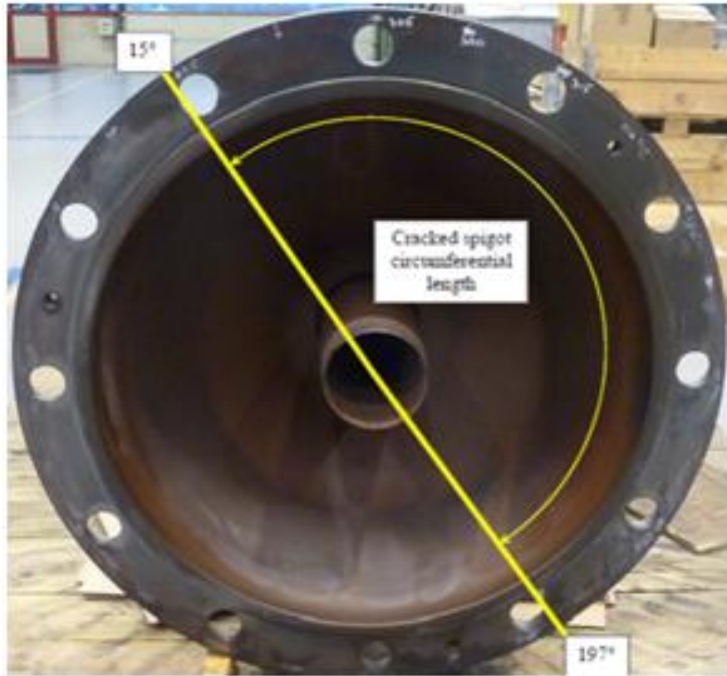
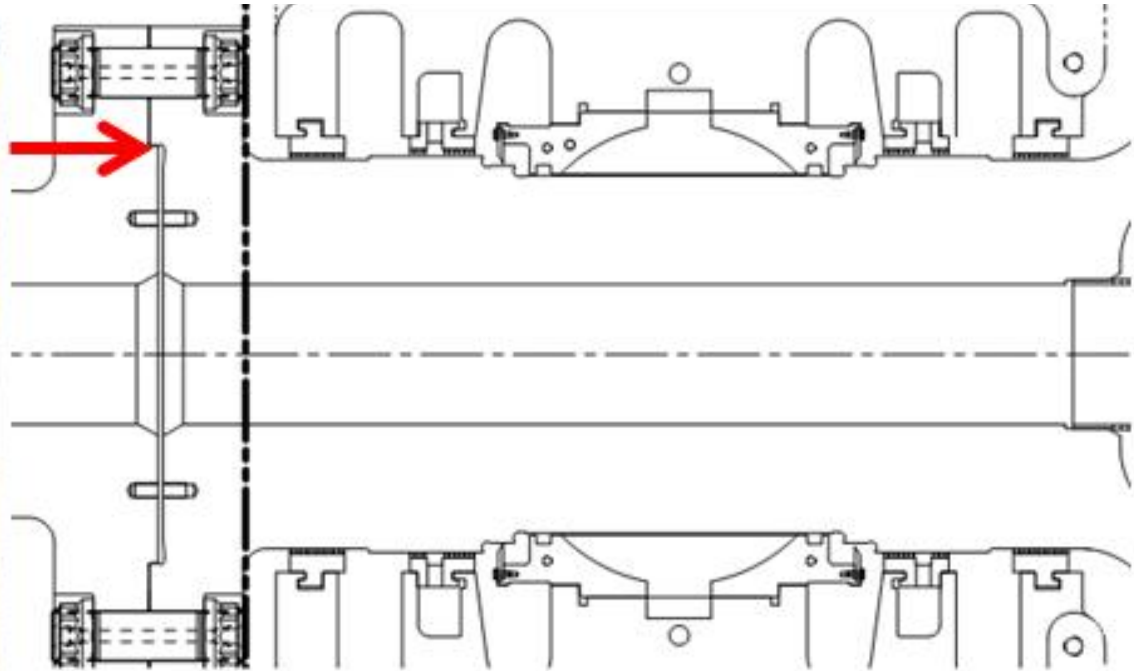
Gas Turbine Rotor Crack - confirmed

180deg circumferential crack detected, 18mm deep

at the Turbine forward stub shaft, at the marriage joint near the bearing 2

absence of 2X can be possibly explained by lack of radial preload to open the crack, due to vicinity of bearing 2.
